YOUR ONESURVEY  
**HOME REPORT**

17e Court Street  
Dundee  
DD3 7QS

# SINGLE SURVEY

A report on the condition of the property, with categories being rated from 1 to 3.

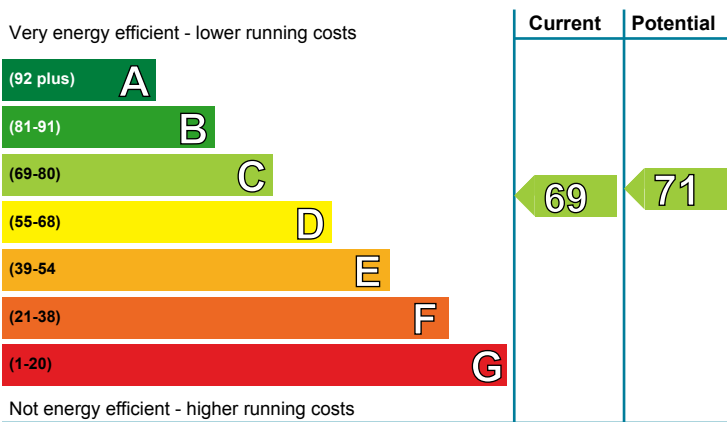
## Energy Efficiency Rating

This graph shows the current efficiency of your home, taking into account both energy efficiency and fuel costs. The higher this rating, the lower your fuel bills are likely to be.

Your current rating is **band C (69)**. The average rating for EPCs in Scotland is **band D (61)**.

The potential rating shows the effect of undertaking all of the improvement measures listed within your recommendations report.
