YOUR ONESURVEY
HOME REPORT

33f Blackness Avenue
Dundee
DD2 1EY

SINGLE SURVEY

Surveyor Reference	DD202602-51011
Customer	Cara Brophy
Selling address	33f Blackness Avenue Dundee DD2 1EY
Date of Inspection	24/02/2026
Prepared by	Mark Smith, BSc MRICS D M Hall - Dundee

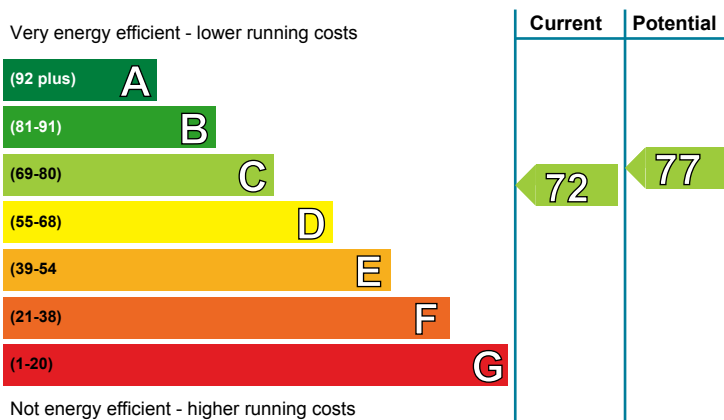
Energy Efficiency Rating

This graph shows the current efficiency of your home, taking into account both energy efficiency and fuel costs. The higher this rating, the lower your fuel bills are likely to be.

Your current rating is **band C (72)**. The average rating for EPCs in Scotland is **band D (61)**.

The potential rating shows the effect of undertaking all of the improvement measures listed within your recommendations report.

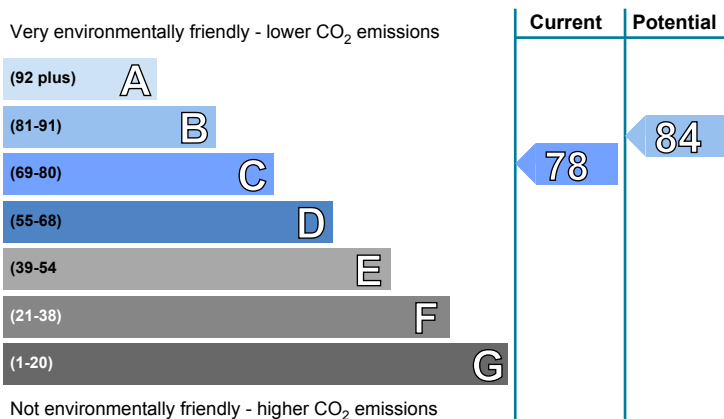
Environmental Impact (CO₂) Rating

This graph shows the effect of your home on the environment in terms of carbon dioxide (CO₂) emissions. The higher the rating, the less impact it has on the environment.
