YOUR ONESURVEY
HOME REPORT

49 Ceres Crescent
Broughty Ferry, Dundee
DD5 3JP

SINGLE SURVEY

Single Survey

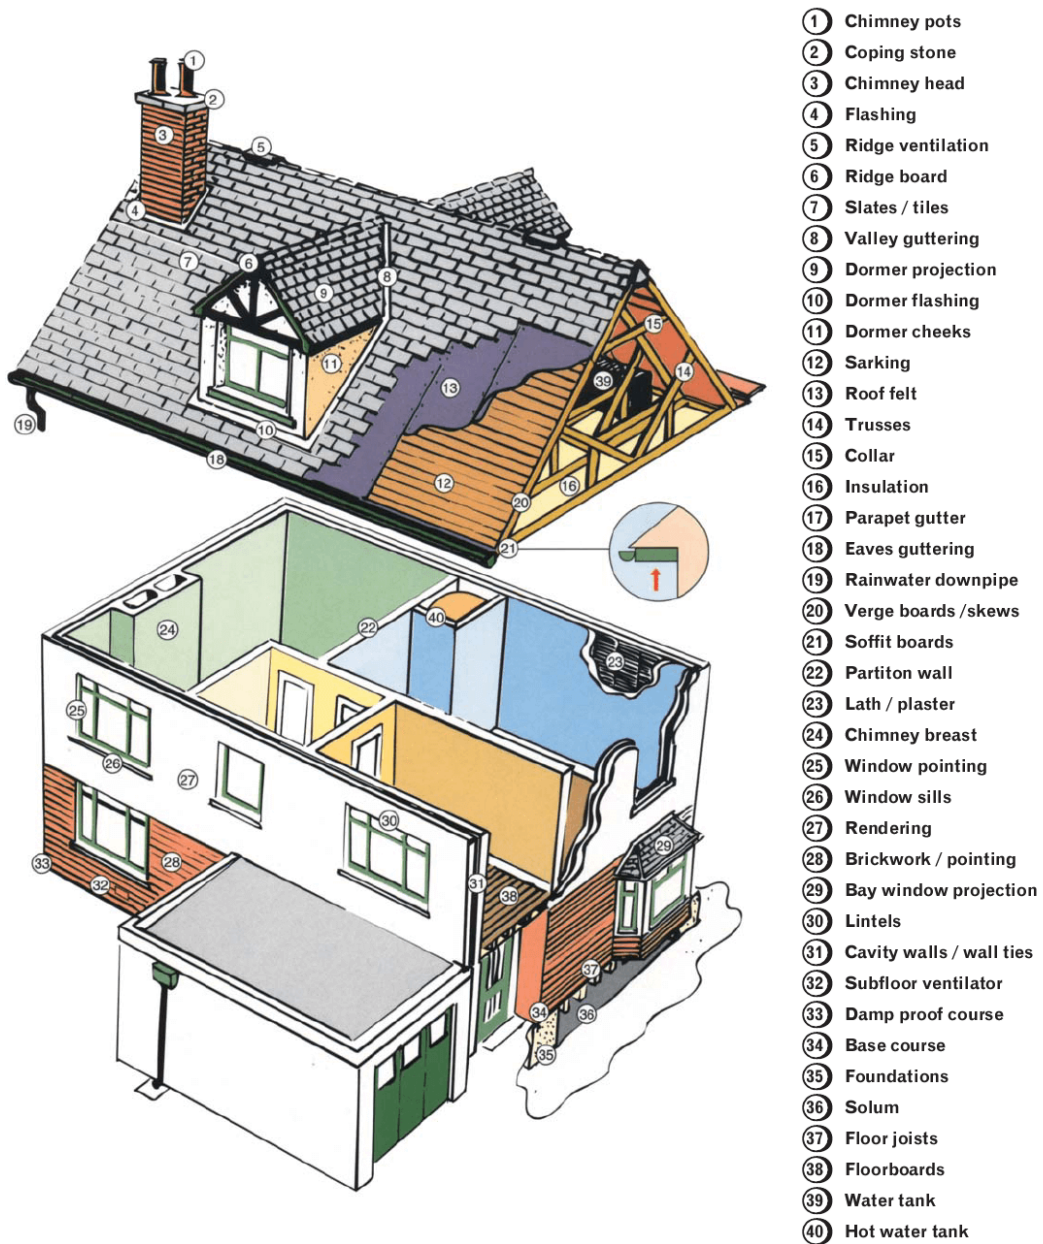
Sectional Diagram showing elements of a typical house

- ① Chimney pots
- ② Coping stone
- ③ Chimney head
- ④ Flashing
- ⑤ Ridge ventilation
- ⑥ Ridge board
- ⑦ Slates / tiles
- ⑧ Valley guttering
- ⑨ Dormer projection
- ⑩ Dormer flashing
- ⑪ Dormer cheeks
- ⑫ Sarking
- ⑬ Roof felt
- ⑭ Trusses
- ⑮ Collar
- ⑯ Insulation
- ⑰ Parapet gutter
- ⑱ Eaves guttering
- ⑲ Rainwater downpipe
- ⑳ Verge boards / skews
- ㉑ Soffit boards
- ㉒ Partiton wall
- ㉓ Lath / plaster
- ㉔ Chimney breast
- ㉕ Window pointing
- ㉖ Window sills
- ㉗ Rendering
- ㉘ Brickwork / pointing
- ㉙ Bay window projection
- ㉚ Lintels
- ㉛ Cavity walls / wall ties
- ㉜ Subfloor ventilator
- ㉝ Damp proof course
- ㉞ Base course
- ㉟ Foundations
- ㊱ Solum
- ㊲ Floor joists
- ㊳ Floorboards
- ㊴ Water tank
- ㊵ Hot water tank

Reference may be made in this report to some or all of the above component parts of the property. This diagram may assist you in locating and understanding these items.

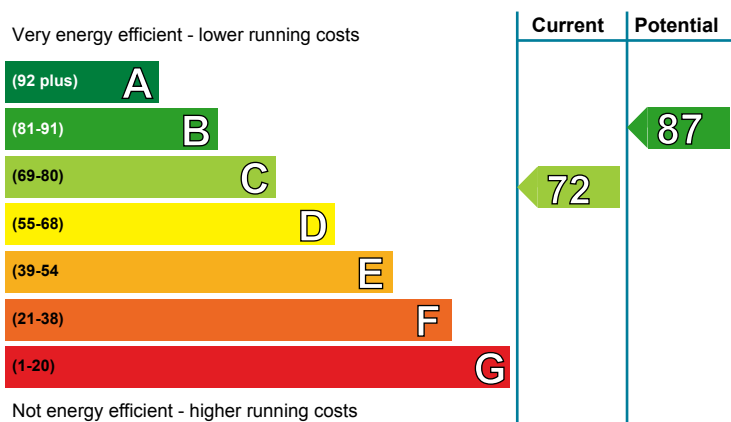
Energy Efficiency Rating

This graph shows the current efficiency of your home, taking into account both energy efficiency and fuel costs. The higher this rating, the lower your fuel bills are likely to be.

Your current rating is **band C (72)**. The average rating for EPCs in Scotland is **band D (61)**.

The potential rating shows the effect of undertaking all of the improvement measures listed within your recommendations report.

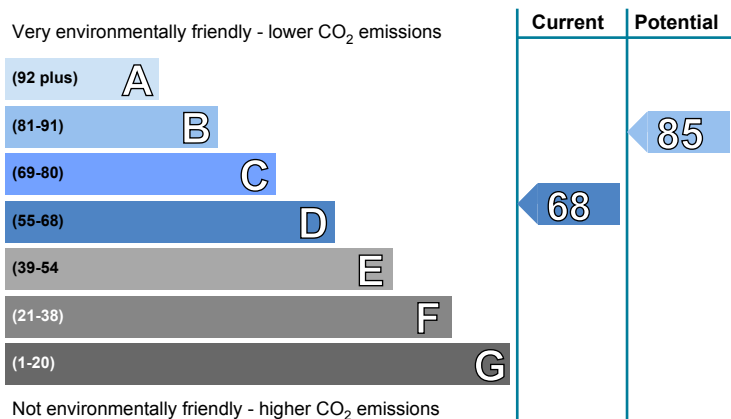
Environmental Impact (CO₂) Rating

This graph shows the effect of your home on the environment in terms of carbon dioxide (CO₂) emissions. The higher the rating, the less impact it has on the environment.
