YOUR ONESURVEY
HOME REPORT

14e Tay Street
Monifieth, Dundee
DD5 4BH

SINGLE SURVEY

Single Survey

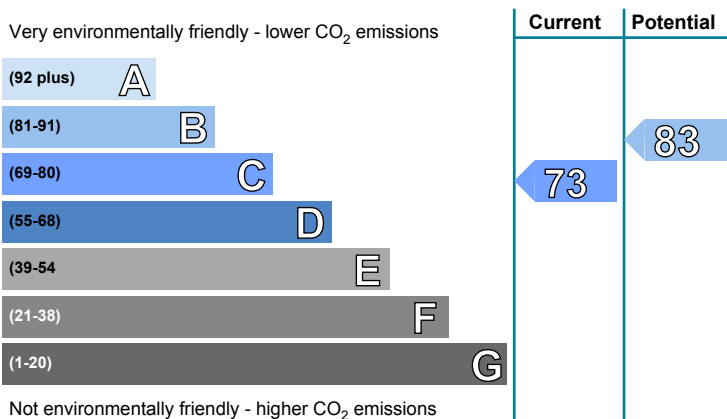
Environmental Impact (CO₂) Rating

This graph shows the effect of your home on the environment in terms of carbon dioxide (CO₂) emissions. The higher the rating, the less impact it has on the environment.
