SINGLE SURVEY

Survey report on:

Surveyor Reference	DD240018
Customer	Leigh Ann Orrock
Selling address	G/R 22 Balerno Street Dundee DD4 8NR
Date of Inspection	17/01/2024
Prepared by	Christopher INACTIVE, MRICS D M Hall - Dundee

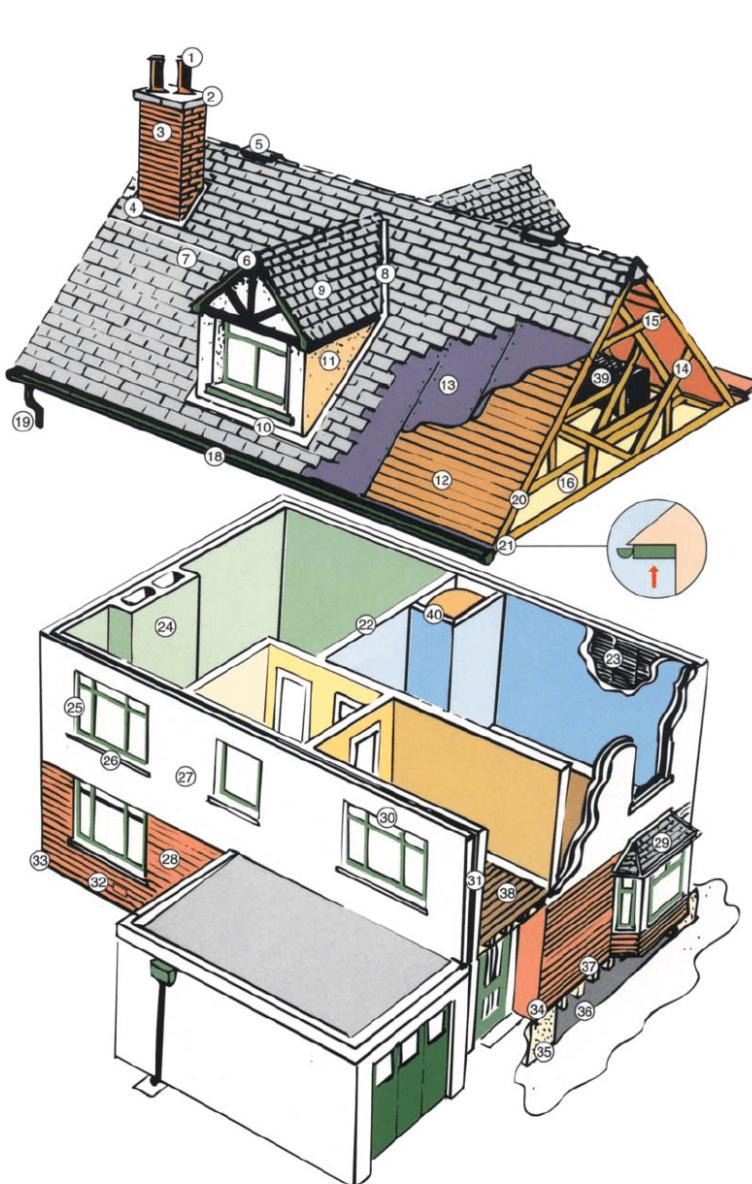
Sectional Diagram showing elements of a typical house

- 1 Chimney pots
- 2 Coping stone
- 3 Chimney head
- 4 Flashing
- 5 Ridge ventilation
- 6 Ridge board
- 7 Slates / tiles
- 8 Valley guttering
- 9 Dormer projection
- 10 Dormer flashing
- 11 Dormer cheeks
- 12 Sarking
- 13 Roof felt
- 14 Trusses
- 15 Collar
- 16 Insulation
- 17 Parapet gutter
- 18 Eaves guttering
- 19 Rainwater downpipe
- 20 Verge boards / skewers
- 21 Soffit boards
- 22 Partition wall
- 23 Lath / plaster
- 24 Chimney breast
- 25 Window pointing
- 26 Window sills
- 27 Rendering
- 28 Brickwork / pointing
- 29 Bay window projection
- 30 Lintels
- 31 Cavity walls / wall ties
- 32 Subfloor ventilator
- 33 Damp proof course
- 34 Base course
- 35 Foundations
- 36 Solum
- 37 Floor joists
- 38 Floorboards
- 39 Water tank
- 40 Hot water tank

Reference may be made in this report to some or all of the above component parts of the property. This diagram may assist you in locating and understanding these items.
